Invitation for pre-bids

For participation in the process of execution of works of rehabilitation and strengthening of Pier I South quay structure in Bar port

On the basis of the contract signed with Port Adria JSC Bar, this Institute has made Main Project Design of rehabilitation and strengthening of Pier 1 south quay structure. This reinforced concrete structure was constructed in 1977. After the catastrophic earthquake in 1979, the Pier was damaged and its rehabilitation was completed in 1981. In 1999, Civil Engineering Faculty of University of Montenegro analyzed the current condition with detailed survey of damaged RC structure of the Pier and made Project design of rehabilitation.

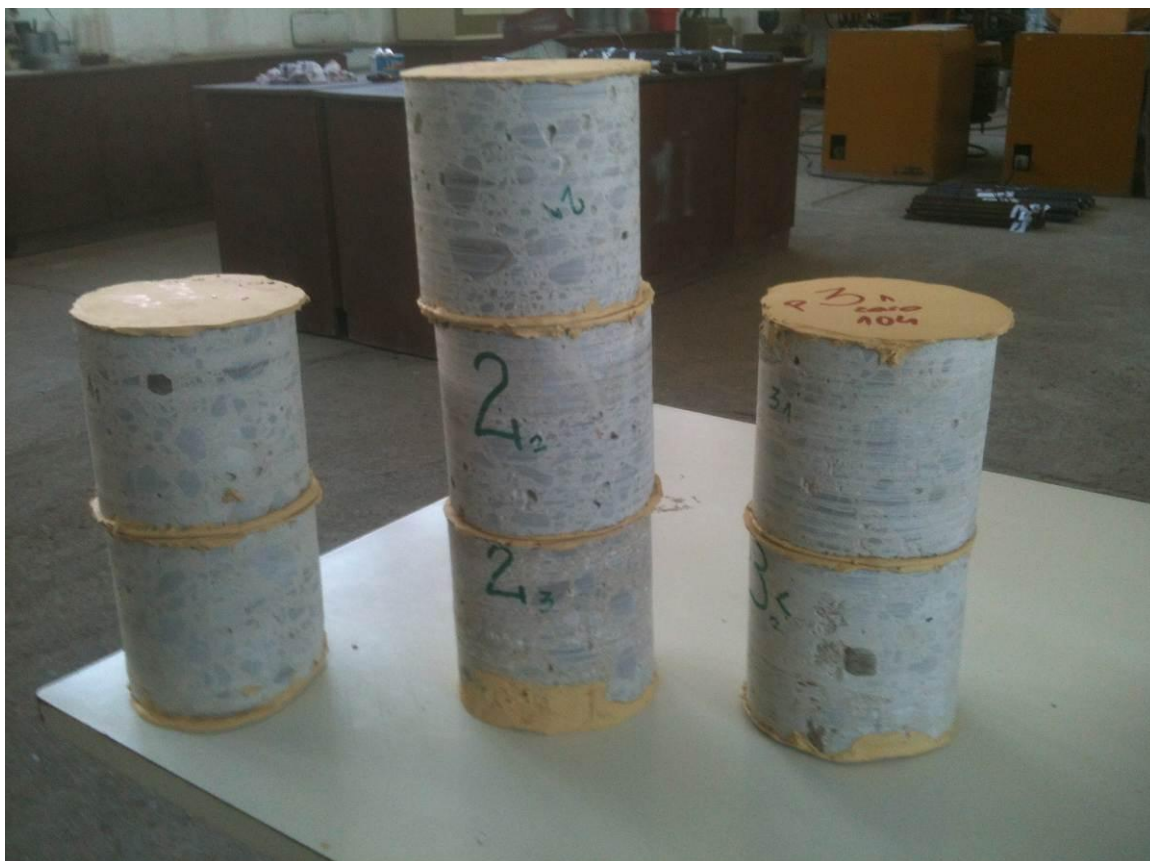
Picture 1. Samples from RC slabs of Pier 1 prepared for testing

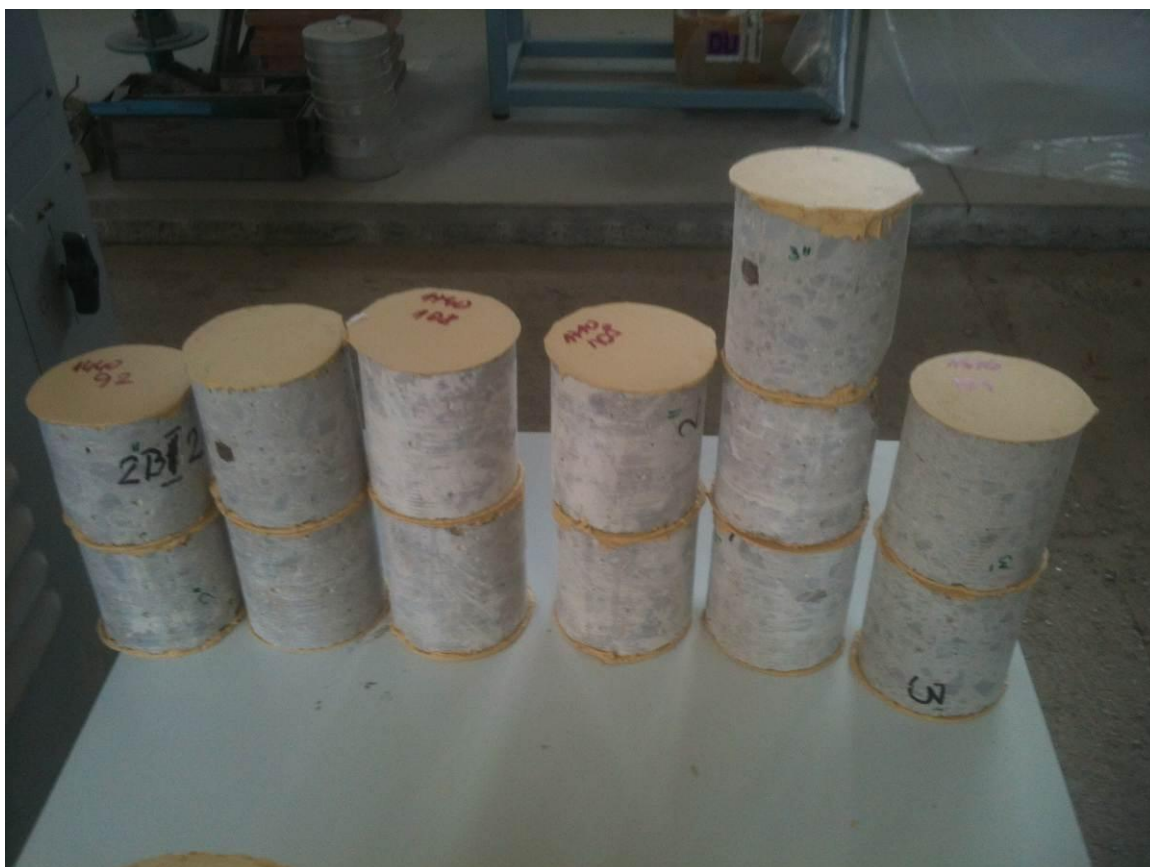
Picture 2. Samples from transverse girders of Pier 1 prepared for testing

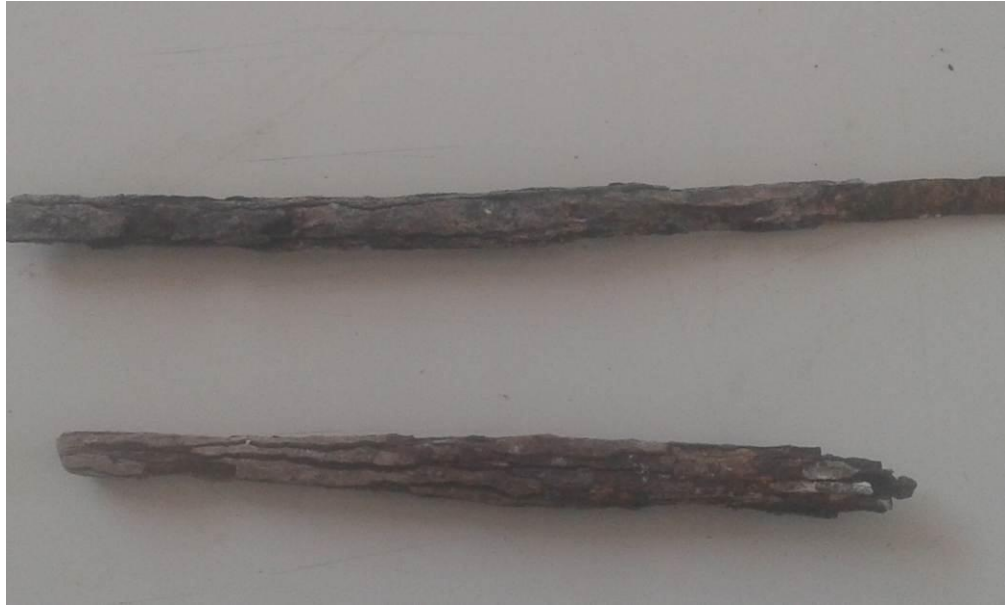
Picture 3.a) pieces of cracked stirrups from transverse girder

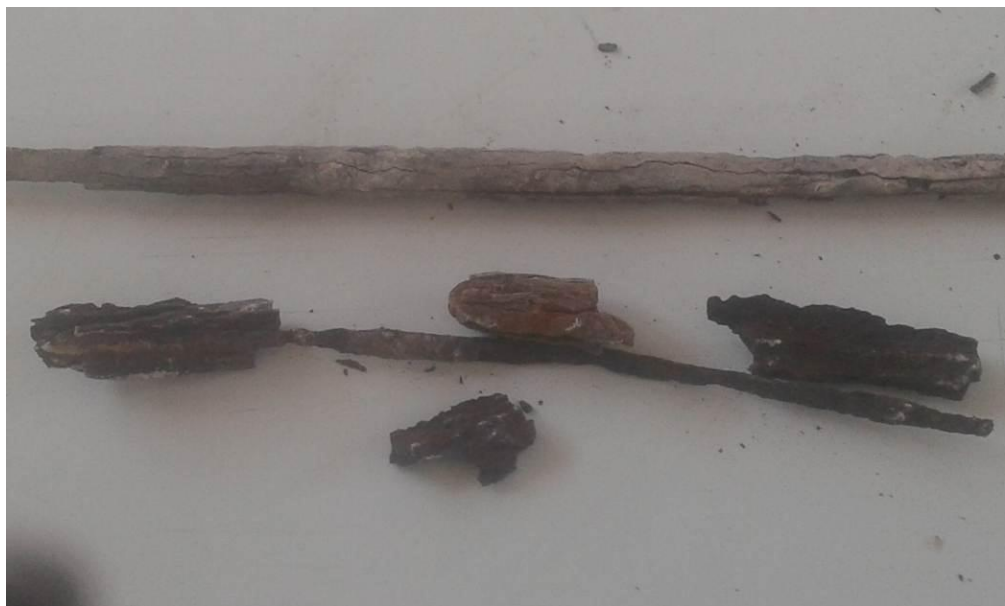
Picture 3.b) pieces of cracked stirrups from transverse girder

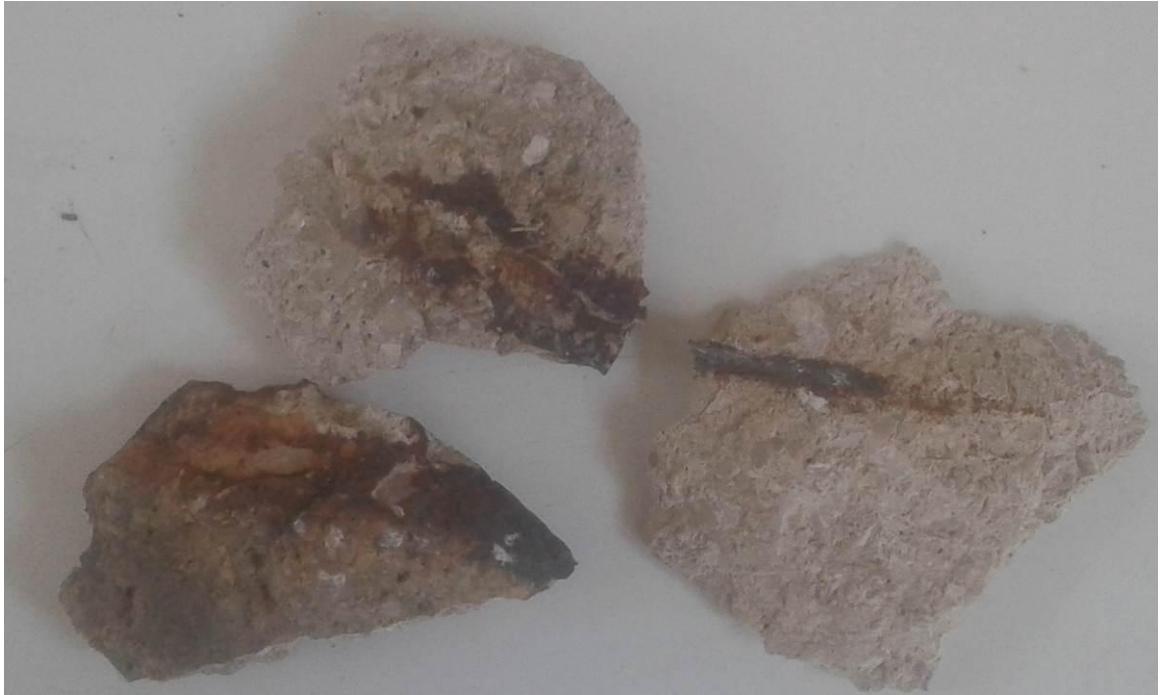
Picture 4. pieces of fallen-off concrete with traces of reinforcement corrosion

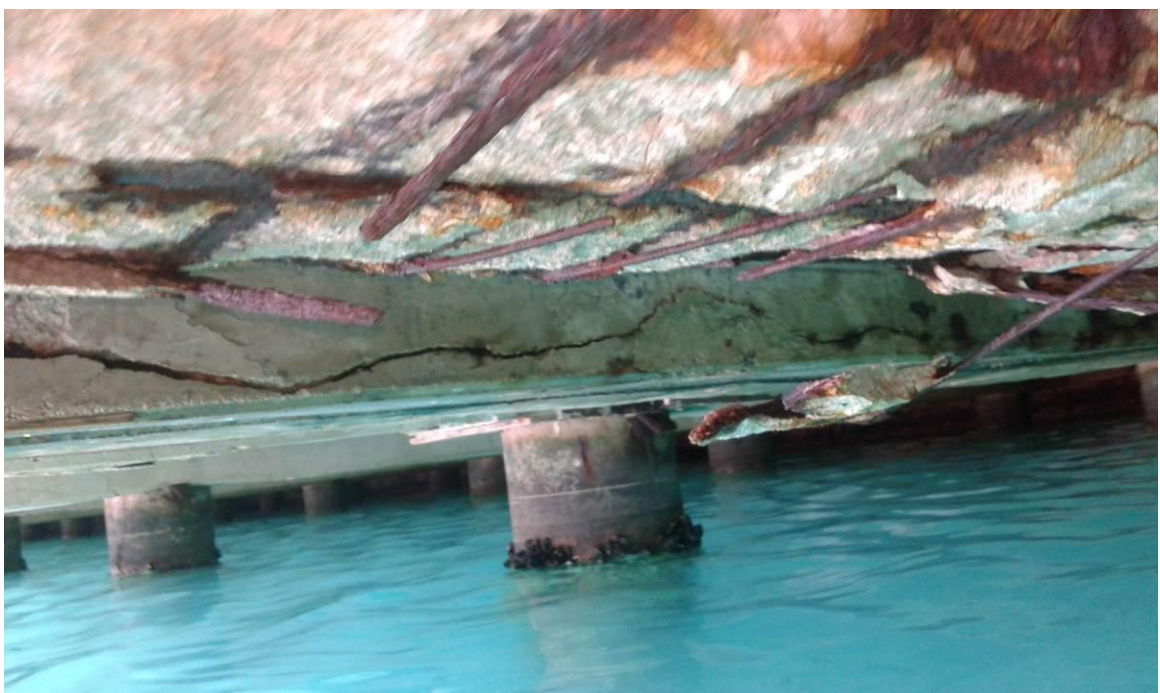
Picture 5.a) Damage TYPE 1 – Forming of unstable block in transverse beam which tends to fall out

For this damage type of the girder, two rehabilitation designs have been chosen. First design consists of expanding cross-section in zones of registered damage. Thickness of the new concrete (concrete jacketing) is 10 cm on the bottom side and 8 cm on the lateral sides. This thickness was chosen to accommodate the reinforcement and provide appropriate protective layer. The height of the expansion depends on the height of the damage, which for transverse girders is from 20 cm to max 55 cm and for longitudinal girders is 25 cm. Execution of the rehabilitation must be carried out according to details in the project (appendix 4.3.2). This rehabilitation design refers to all damaged transverse girders (except for the ones with dilatations and ones on the edge) and longitudinal girders in axes III, IV and V.

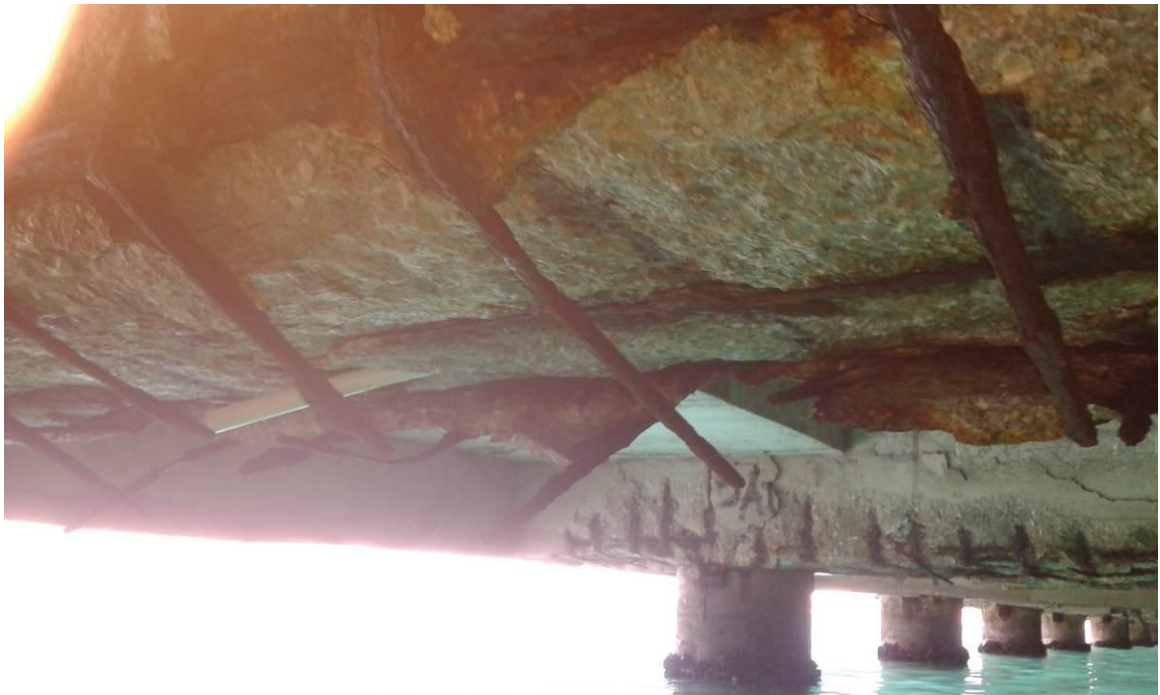
Picture 5.b) Damage TYPE 1 – longitudinal and transverse reinforcement of transverse beams has completely corroded and prolapsed from the original position. Diameter of the reinforcement is significantly reduced

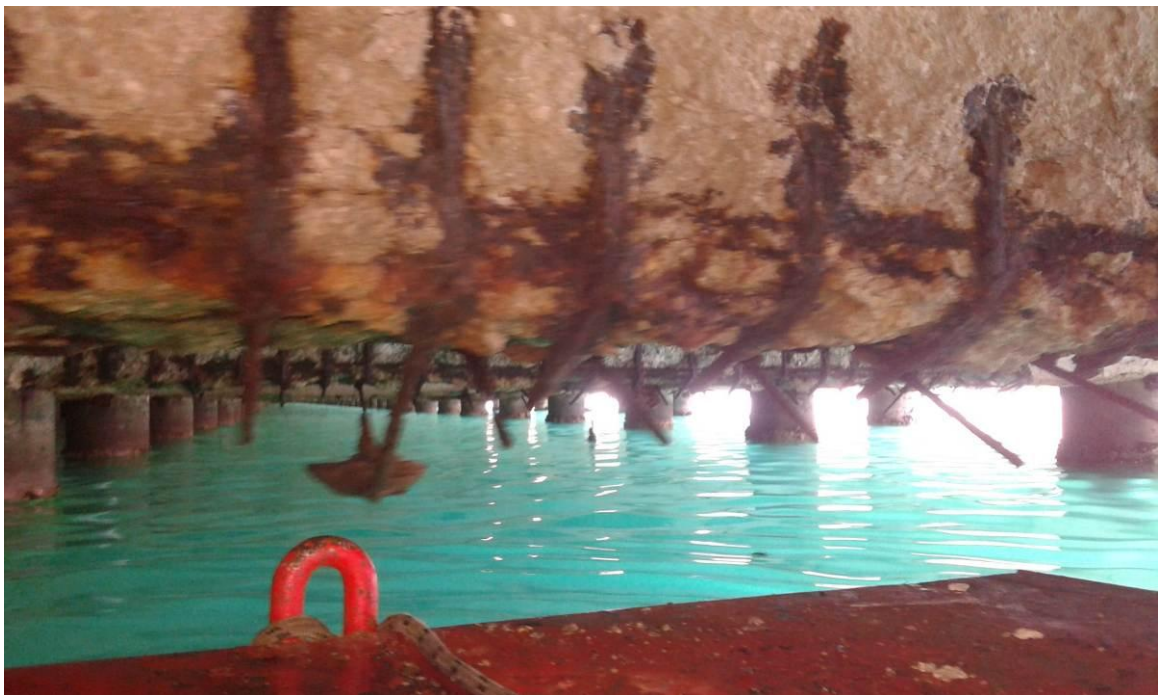
Picture 5.c) Damage TYPE 1 – longitudinal and transverse reinforcement of transversal beams has completely corroded and prolapsed from the original position. Diameter of the reinforcement is significantly reduced

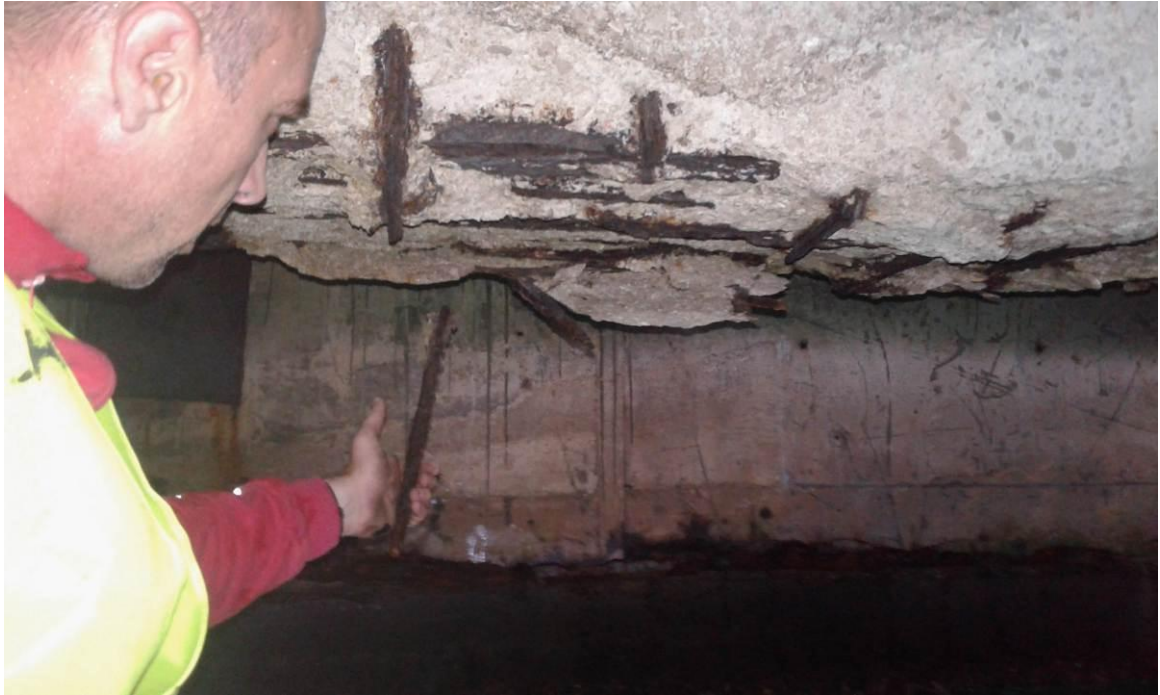
Picture 5.d) Damage TYPE 1 – Detail of breaking by hand of part of transversal reinforcement from transverse beam

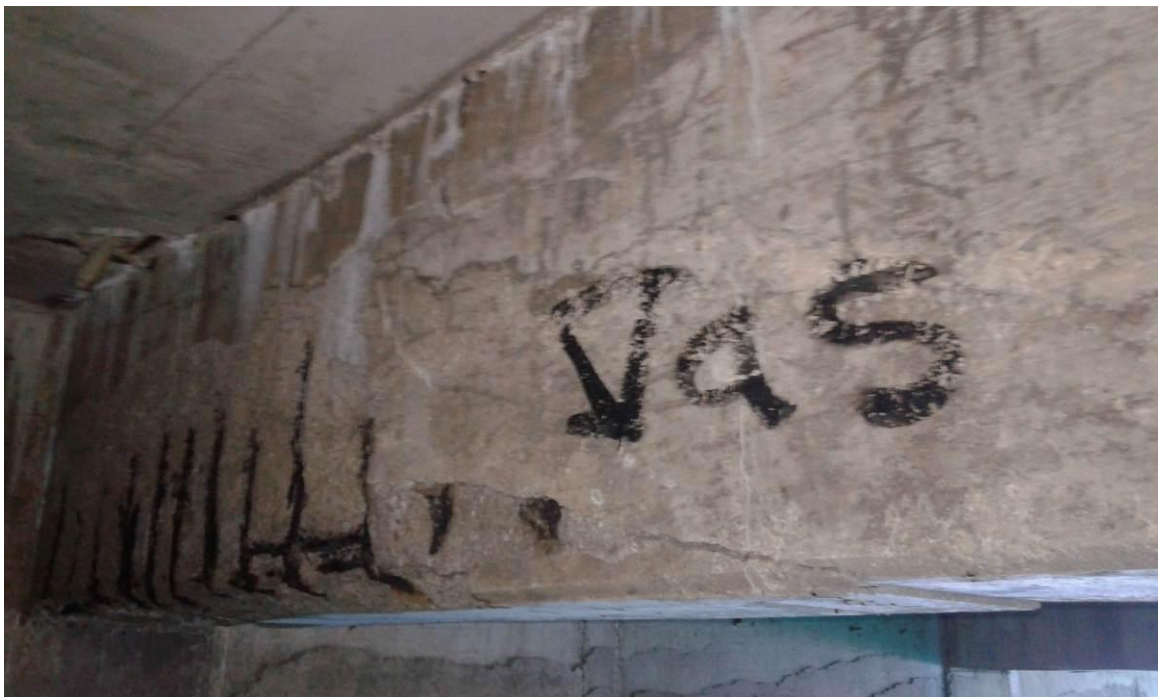
Picture 6. Damage TYPE 1 –Damage of longitudinal beam in the form of block falling off, up to visible transversal reinforcement and one row of longitudinal reinforcement

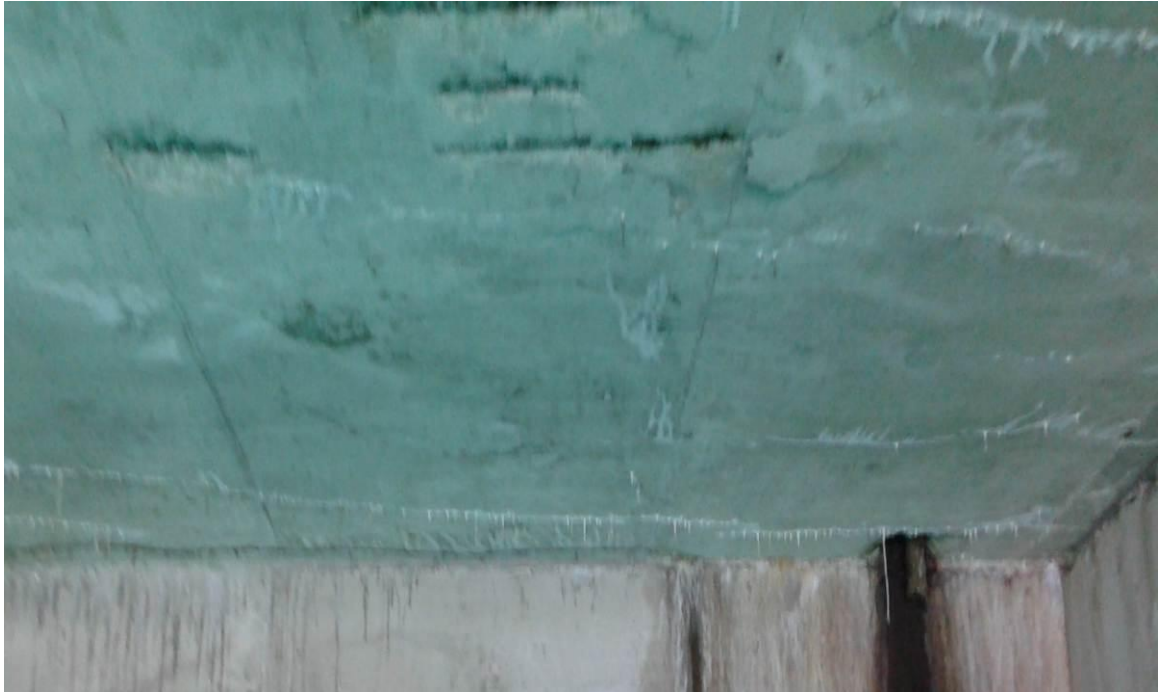
Picture 7. Damage TYPE 1 – RC slab damaged in the form of concrete falling off up to visible reinforcement and peeling off concrete in layers

Longitudinal girders are significantly less damaged, compared to the transversal girders. RC slabs sustained least damages. Damage TYPE 1 on slabs in section 2, according to Pier users, was caused by the impact from cargo falling, during handling. Manner of damage of all structural elements, their numbers and respective percentages are shown in the following tables (Table 4 – Table 7):

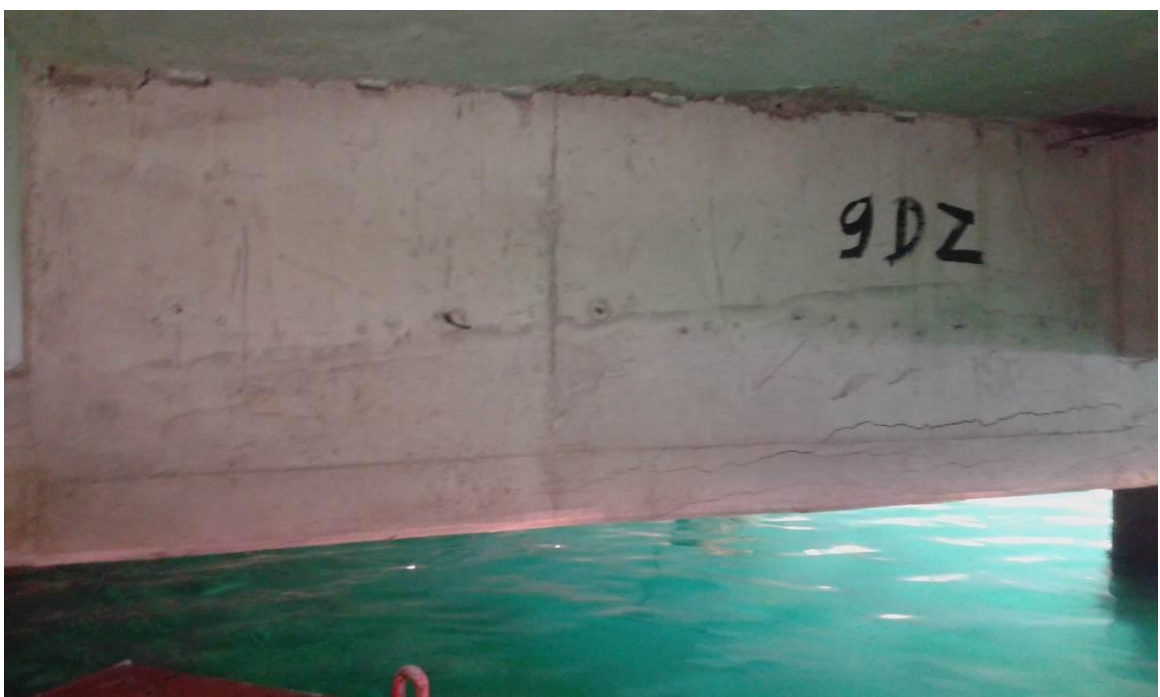
Picture 8. Damage TYPE 2 – cracks are starting to appear in the lower part of the transverse girders in the zone of lower main reinforcement

After preparation for rehabilitation and anti-corrosion coating of reinforcement are carried out, polymer cement primer is applied. Preparation and appliance of the primer is carried out according to the instructions of the manufacturer. After applying the primer, appliance of the polymer mortar is carried out in one or more layers, depending on the size of damage. Thickness of one layer is approx. 3 cm.

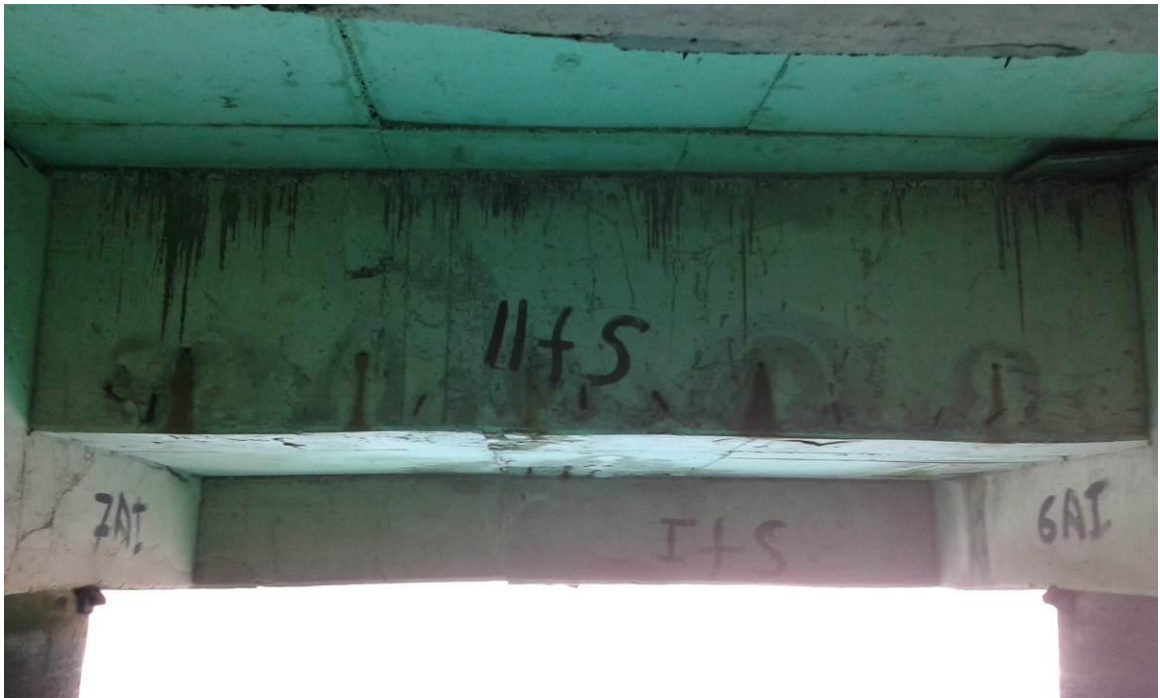
Picture 9. Damage TYPE 2 – Damage of lower slab of boxed girder and longitudinal beams in the form of concrete husking, peeling and falling off in thin layers

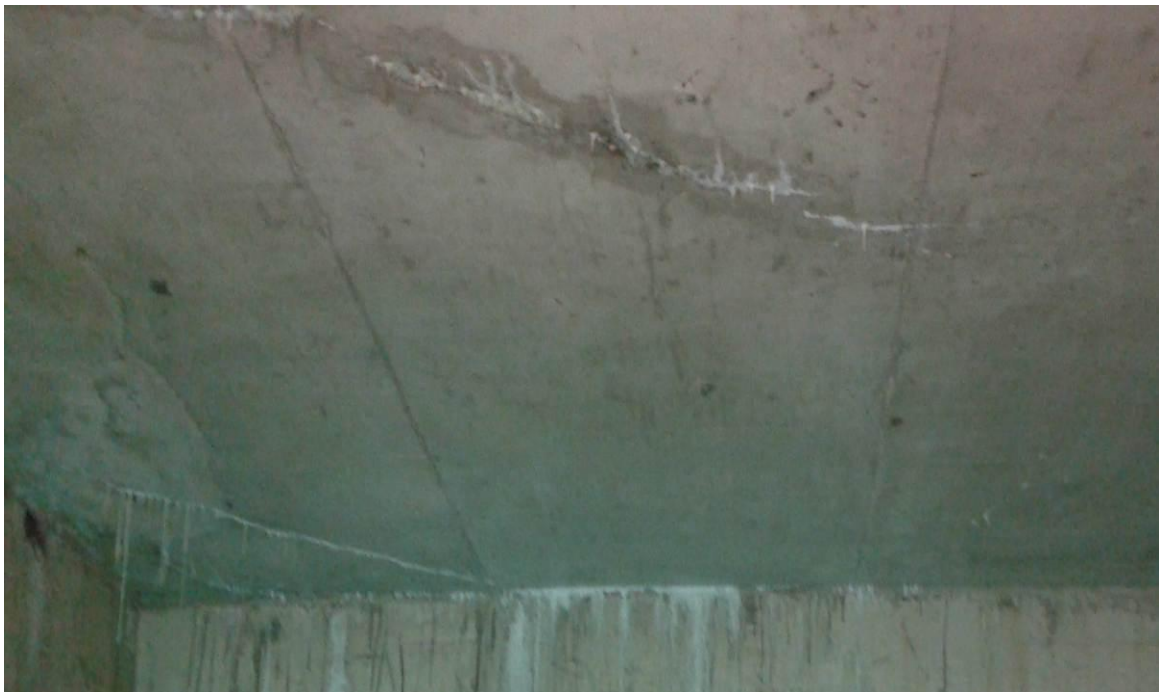
Picture 10. Damage TYPE 2 – Damage of the slab in the form of concrete falling off in thin layers and surface damage due to carbonization
